## Rock slope stability – planar shear failure

This engineering manual describes a slope stability evaluation of an excavation situated next to the road number II/102 Strnady-Stechovice, which is located at the bottom of the Vltava river valley. The stability of the slope has been affected by crumbling stones, rock-layer slip down, underground water damps and unacceptable rock face stabilization since 1931, even though stabilization works are done frequently. The biggest slip failure happened in 1924, when 8,000 m<sup>3</sup> of rock mass slipped down. In 2011 a 2-ton block of stone rolled down on the road. A selected cross-section will be evaluated in the following text.

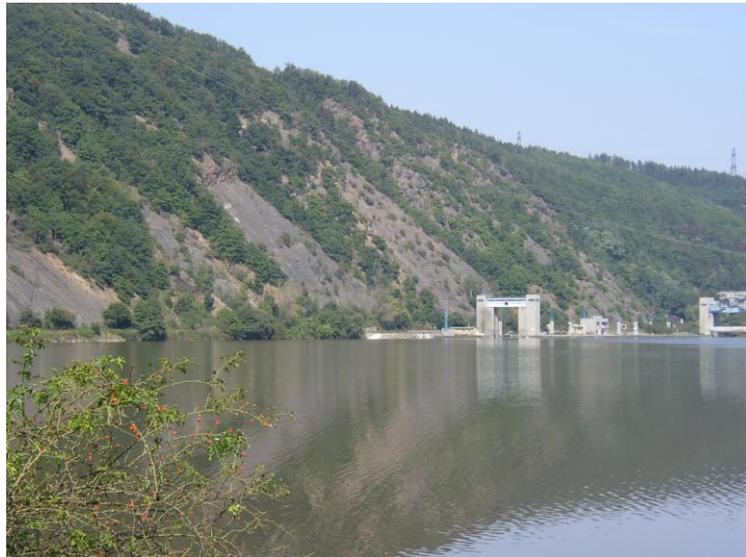
*Picture of the most dangerous section – Vrane nad Vltavou part (photo S. Chamra)*

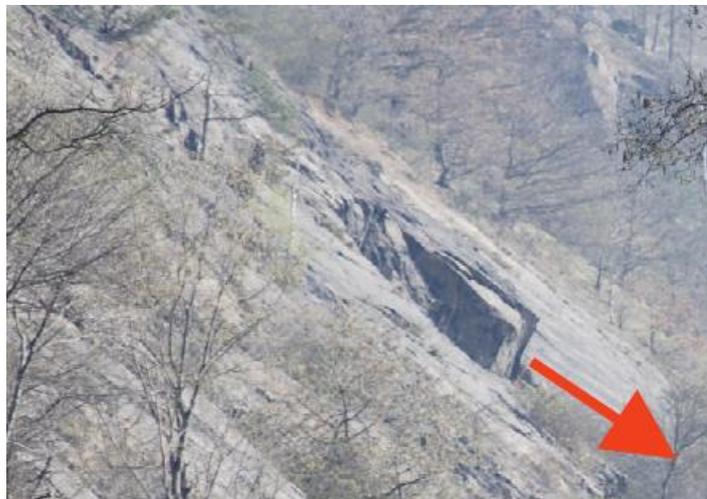
*Rock-block with a translation movement presumption (photo Vaniček 2009)*

Based on a geological investigation and archive documents, the following rock properties were determined (shale) – unit weight  $\gamma = 26 \text{ kN/m}^3$ , shear failure - plane friction  $\varphi' = 38^\circ$ , shear failure - cohesion 0,8 MPa (laboratory measurement on a drilled rock sample), deformation modulus  $E_0 = 10 \text{ MPa}$ .
